FINAL
Coal Ash Impoundment –
Specific Site Assessment Report
Westar Energy
Jeffrey Energy Center

Submitted by:
GEI Consultants, Inc.
6950 South Potomac Street, Suite 300
Centennial, CO 80112

September 2009
Project 091330

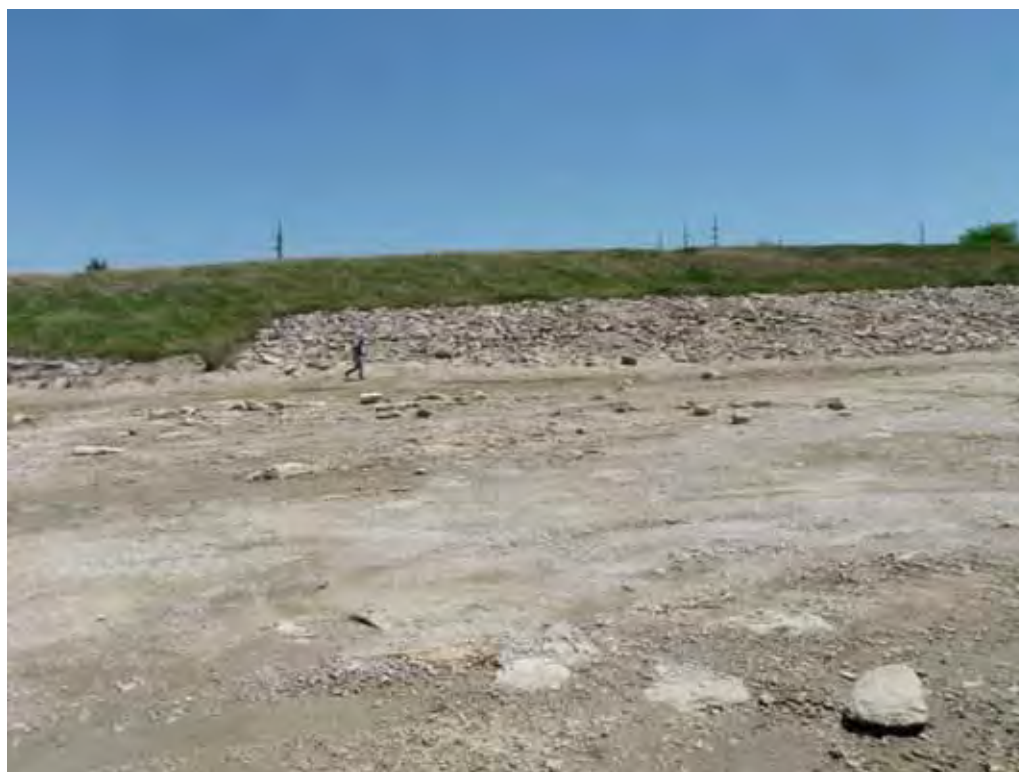
Photo 7 - Emergency Spillway – Looking at right side slope of the spillway along approach channel.

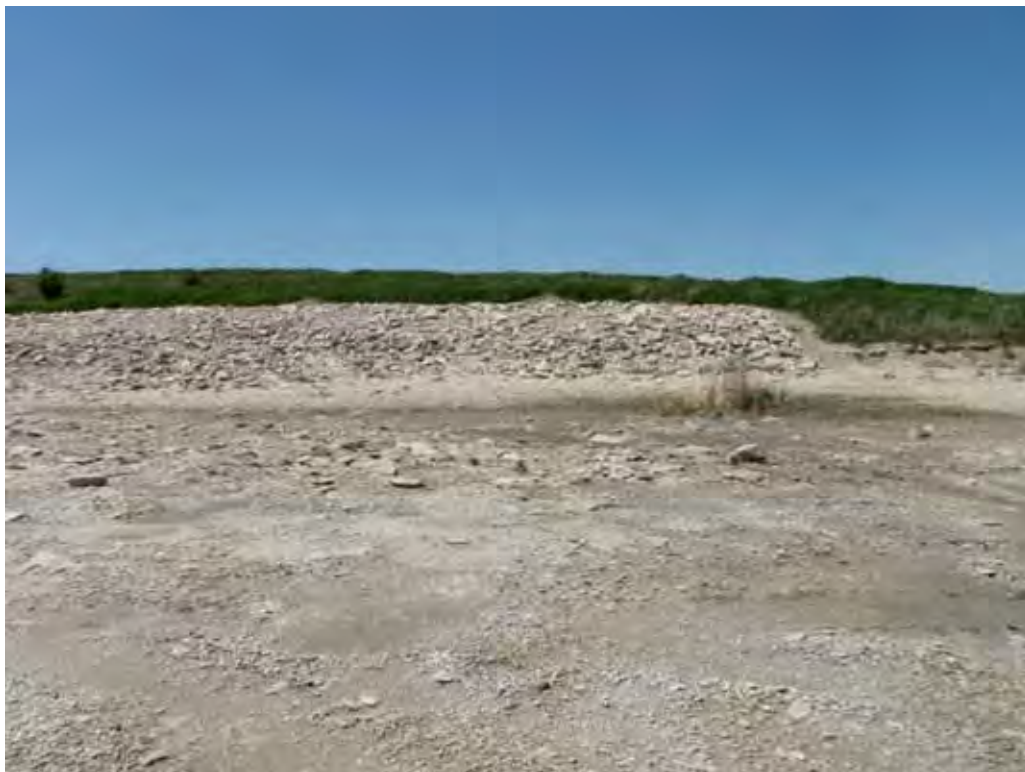
The limestone riprap both upstream and downstream of the concrete control crest showed extensive deterioration along the entire length of the control crest (Photos 1 – 4). Minor concrete spalling was also observed at a few locations on the top of the concrete control crest. The approach channel to the emergency spillway was also observed to have extensive riprap deterioration showing significant variability in riprap size (Photos 5-8). The riprap lining on the channel downstream of the control crest showed less deterioration and more consistent riprap sizes (Photo 9). Several small trees were observed at the exit of the riprap lined spillway channel which should be removed (Photo 10).

Photo 8 - Emergency Spillway – Looking downstream, towards control crest from waters edge.

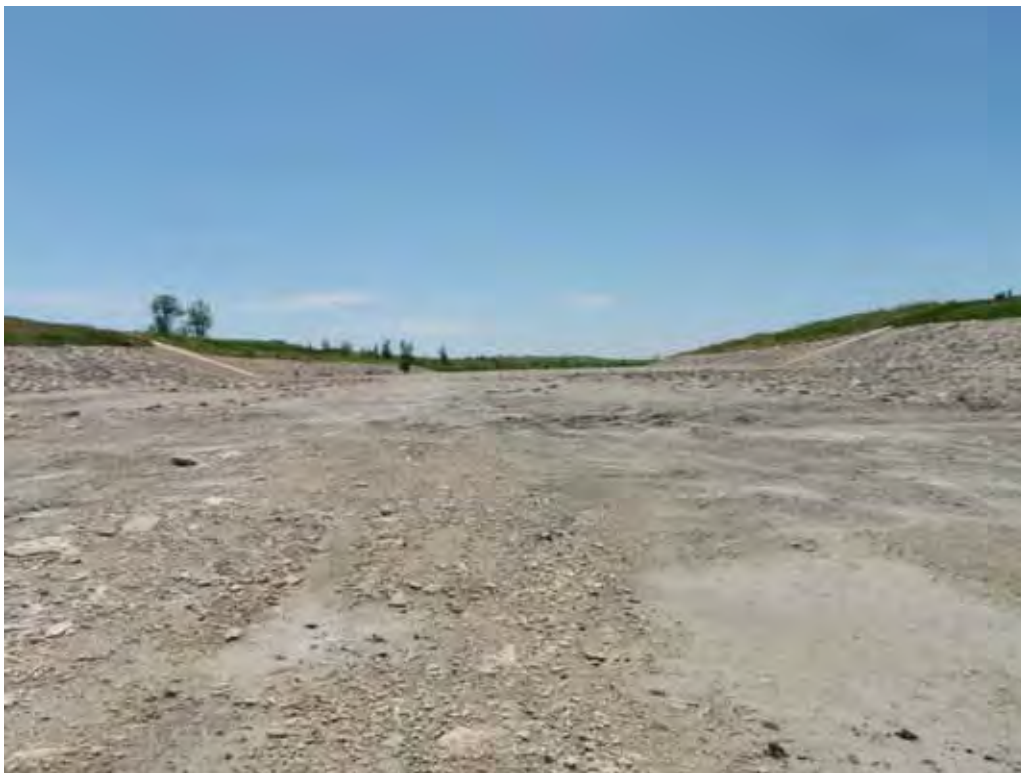
Photo 9 - Emergency Spillway – Looking upstream near the end of the riprap lined channel. (Note: Small tree on left side slope of spillway)

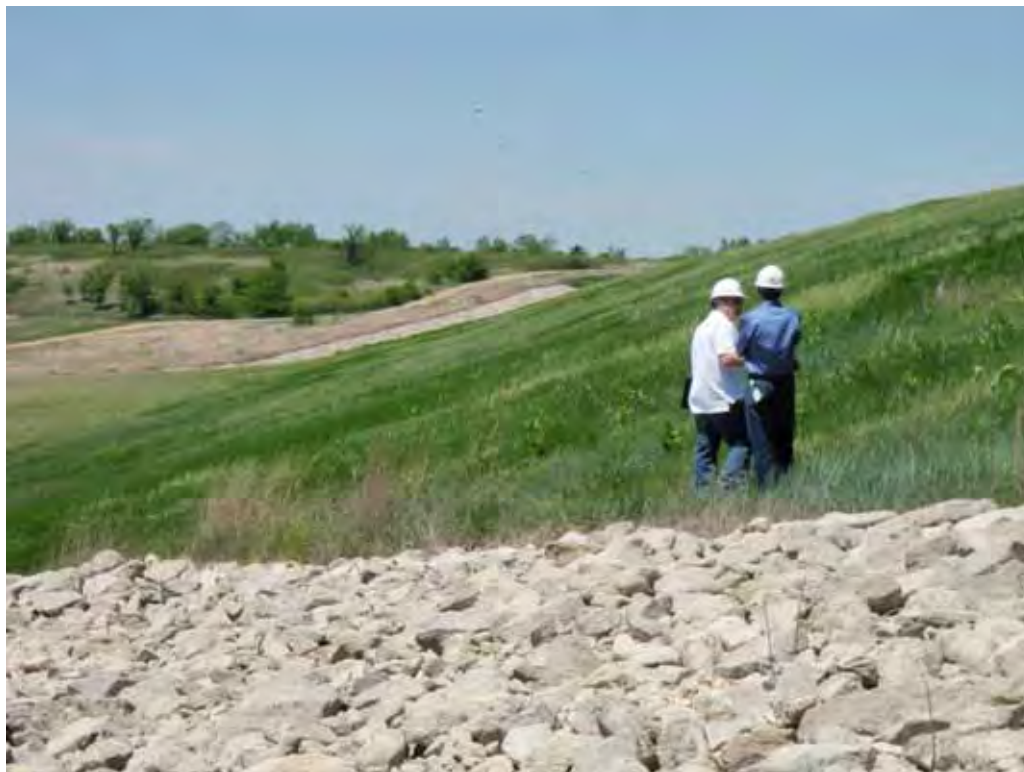
The toe drain was dry at the time of the assessment and appeared to be in good condition (Photos 11, 12, 14). Significant amounts of sediment were observed throughout the majority of the left toe drain channel (Photos 15, 17). The sediment deposits in the left toe drain channel appear to be from surface erosion observed near the left abutment and areas downstream of the dam. Only minor amounts of sediment were observed in the right toe

Photo 14 - Left Toe Drain Ditch – Looking up left toe drain about halfway down channel.

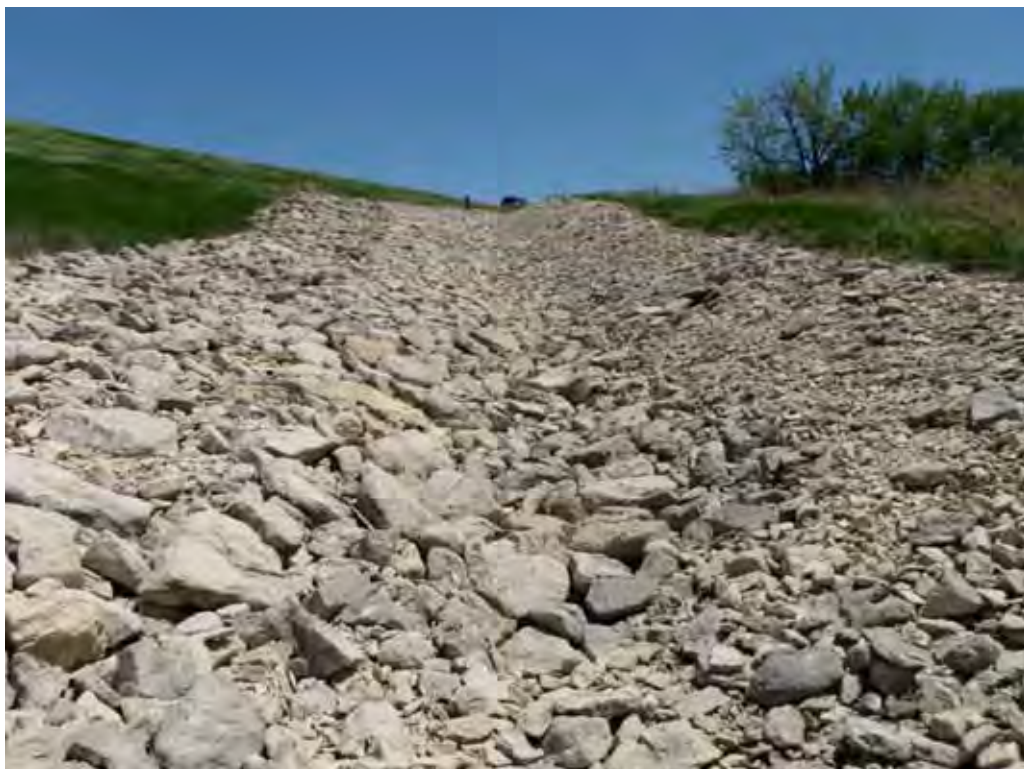
Photo 15 - Left Toe Drain Ditch – Looking at sediment deposits in left toe drain ditch, before curve in channel at the toe of the stability berm.

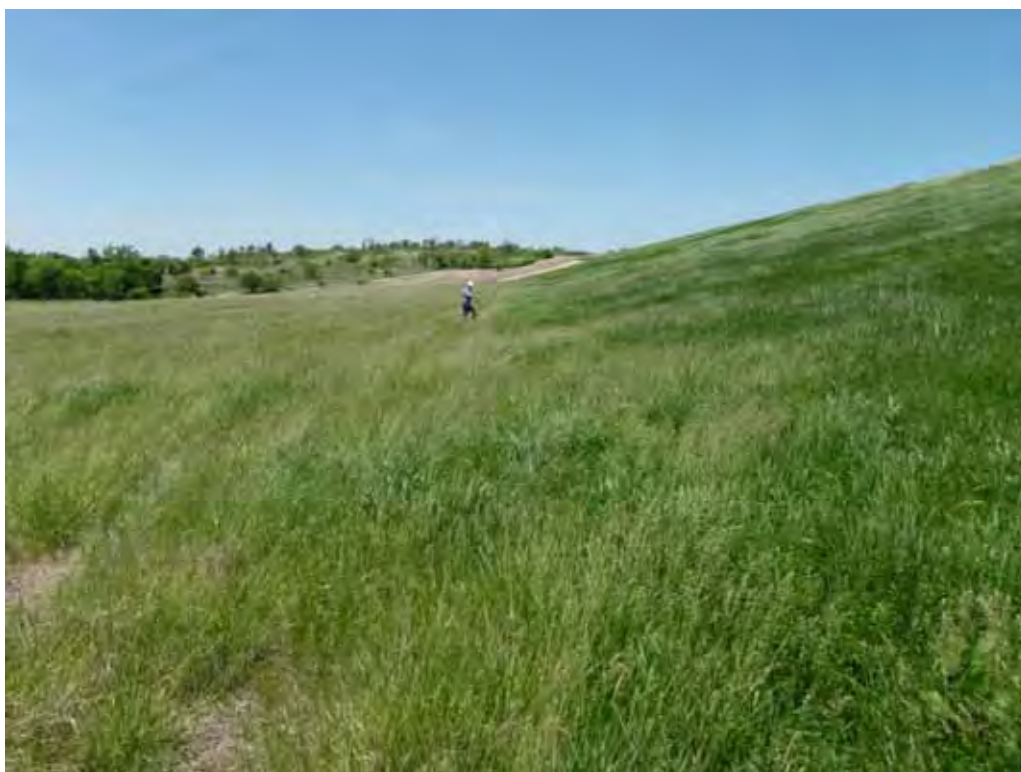
Photo 17 - Left Toe Drain Ditch – Looking towards dam centerline along toe drain (Note: sediment along channel).

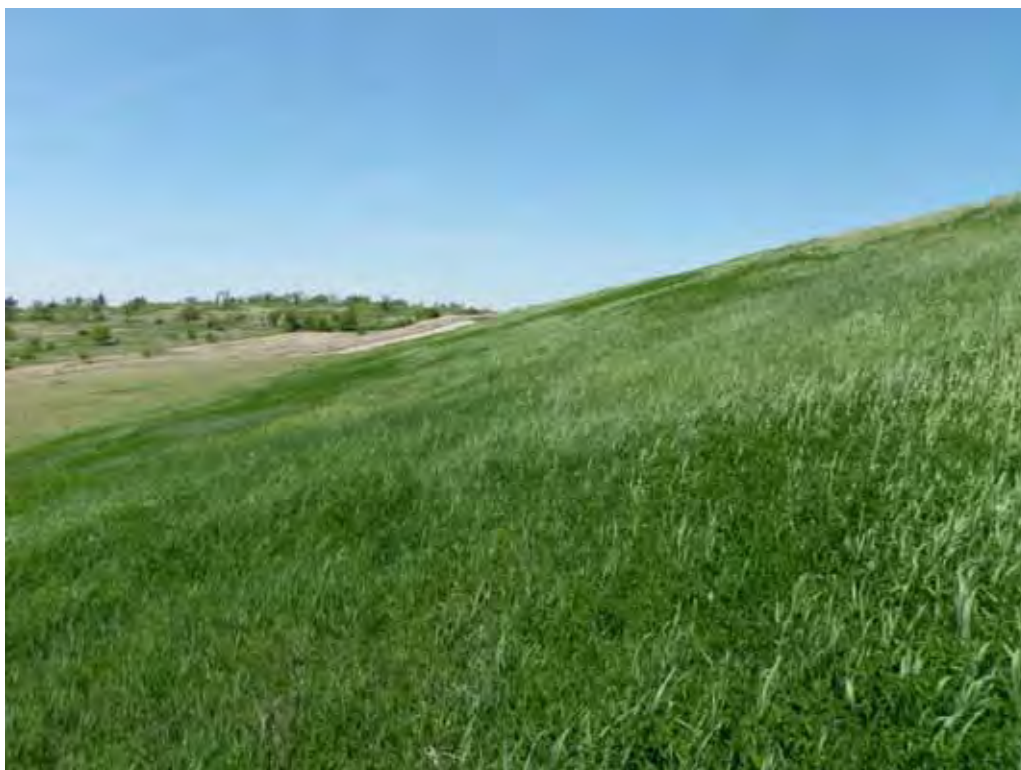
drain channel (Photos 23 and 25). Additionally, a significant amount of silt and sediment has accumulated behind the V-notch weir (Photo 19 – 21).

Photo 19 - Toe Drain V-Notch Weir – Looking downstream towards toe drain and V-notch weir, standing on top of stability berm. (Note: Significant sediment buildup).

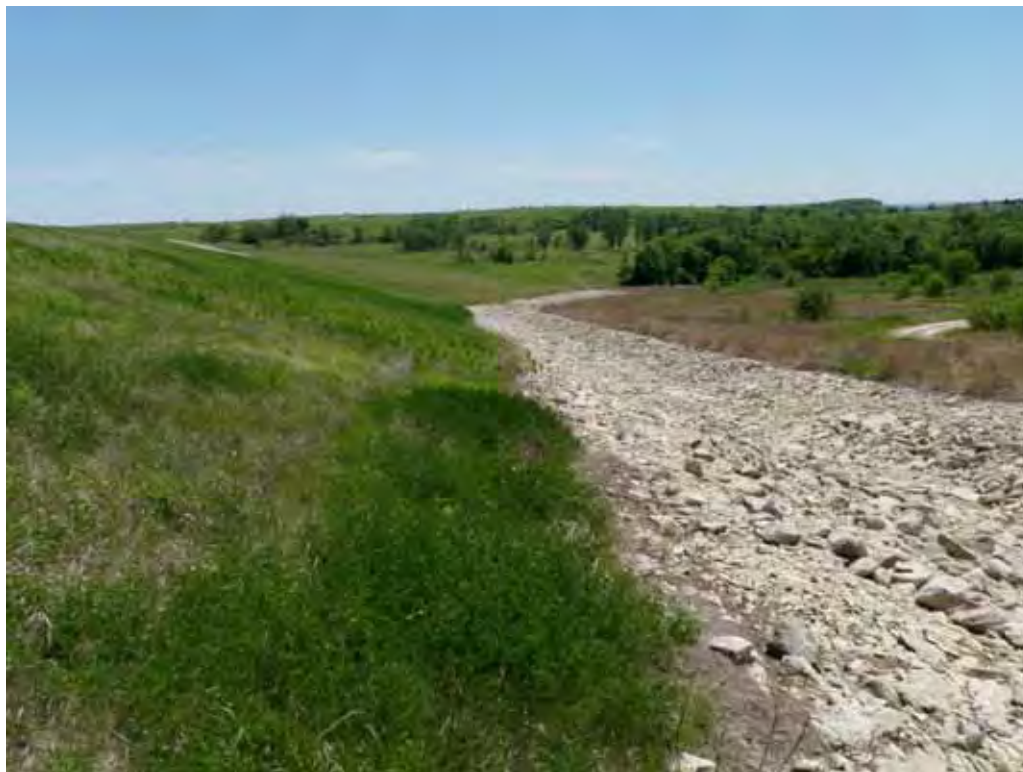
traverse the length of the dam (Photos 26 – 29). The dam crest also has some low lying grassy vegetation that should be cleared or maintained to an acceptable level to make visual inspection of the dam easier.

Photo 26 - Dam Crest – Looking along dam crest from right abutment to left abutment.

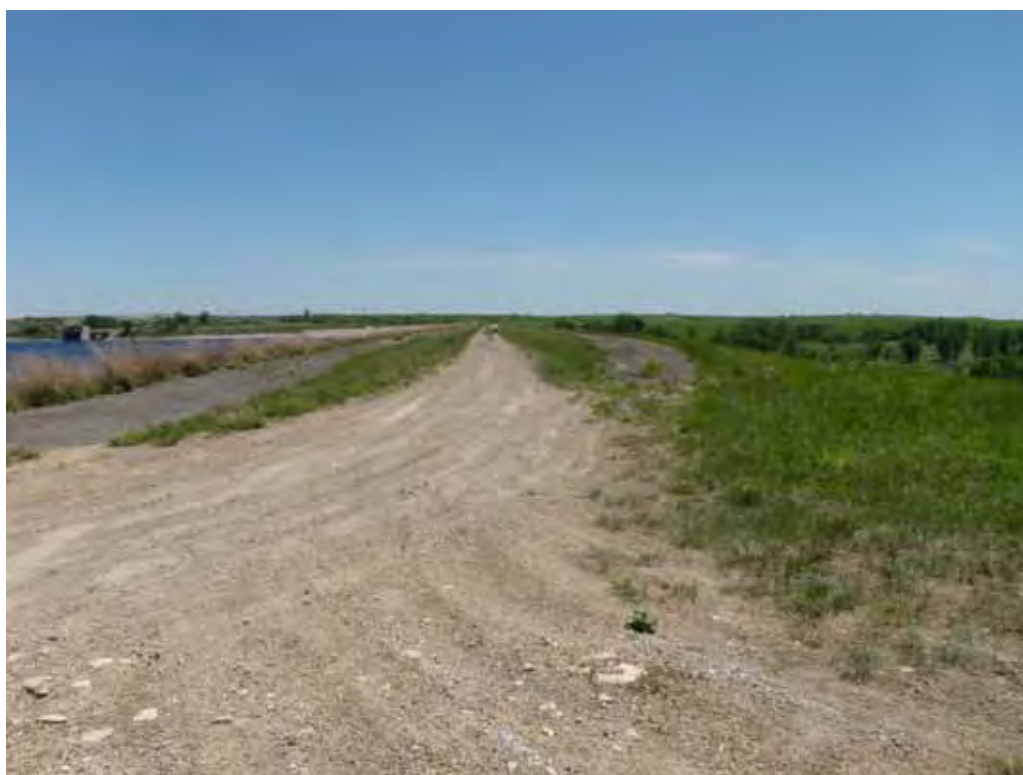
Photo 27 - Dam Crest – Looking along dam crest from dam centerline to right abutment.

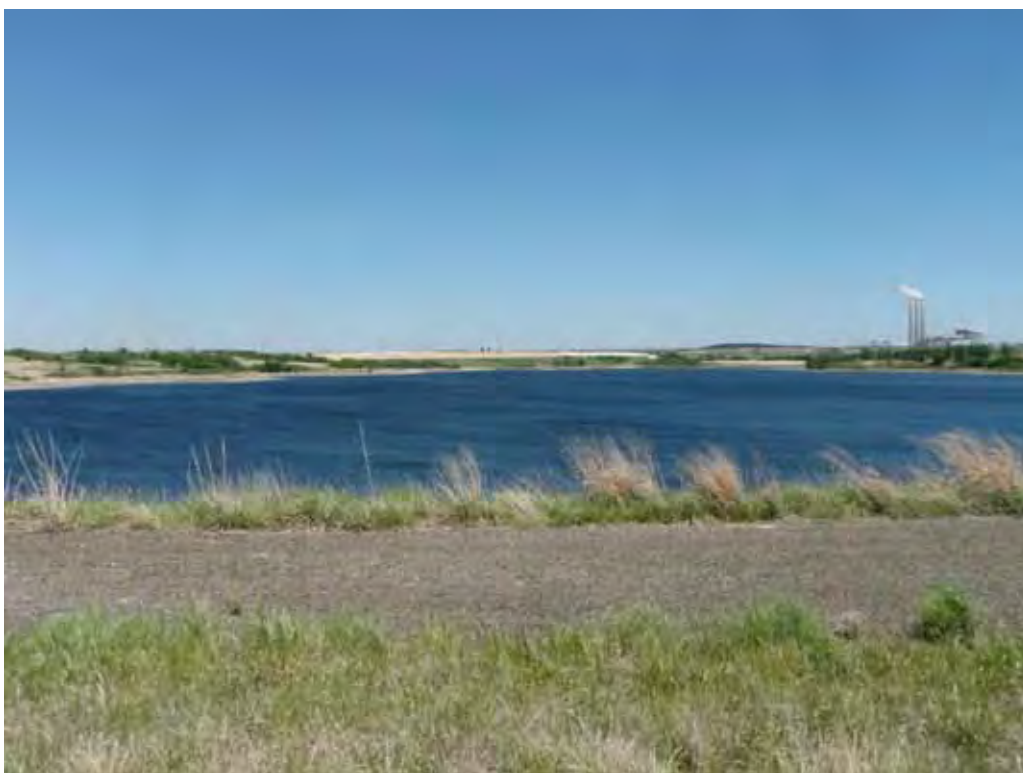
Photo 29 - Dam Crest – Looking along dam crest from dam centerline to left abutment.

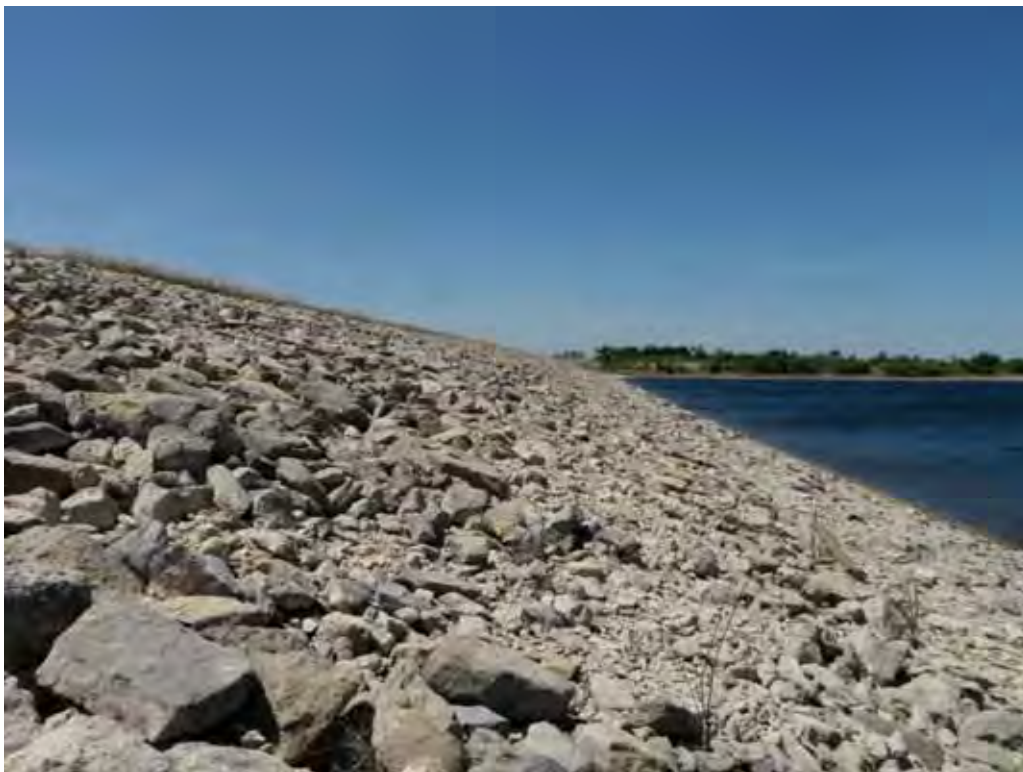
The upstream slope of the dam is protected by riprap and appeared to be in satisfactory condition. No vegetation or signs of instability were observed along the upstream slope (Photos 30 – 33). However, noticeable weathering and deterioration of the riprap was observed near the normal operating pool elevation, this is likely due to wave and freeze/thaw action (Photo 31).

Photo 31 - Upstream Slope – Looking towards left abutment, standing about halfway up the upstream slope of dam.
